Incident Analysis Report: B696 MOVER Event, August 19, 2004

Report Serial Number: 0514

November 11, 2004, Rev. 1

Lawrence
Livermore
National
Laboratory

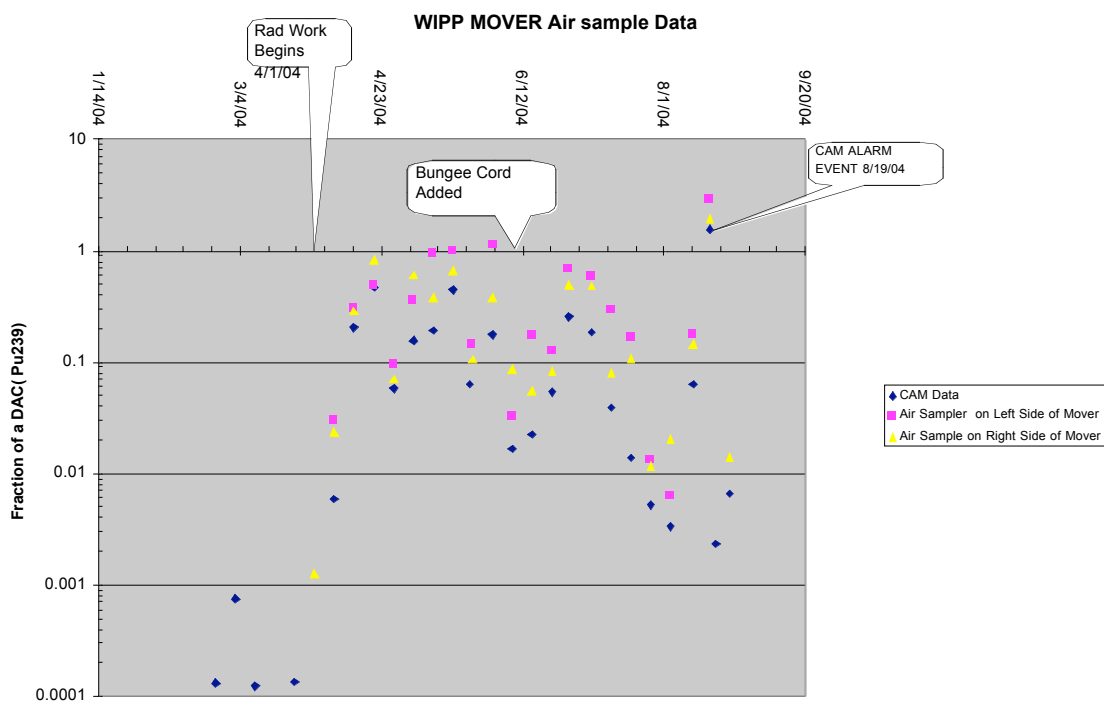
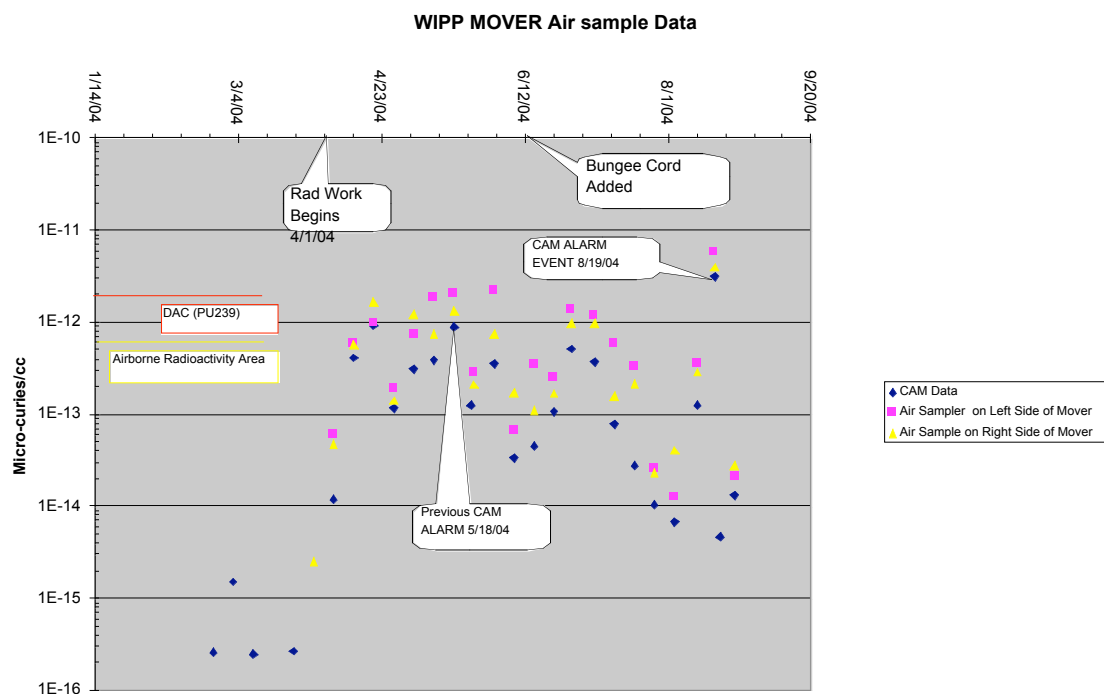
Figure 5. Air sample data show a chronic airborne radioactivity condition present in the MOVER from April 1, 2004, through August 19, 2004.

Most of the positive airborne radioactivity samples were less than the activity level that would have caused the CAM to alarm, and many were below the notification level employed by the Radiation Measurements Laboratory (RML) of 10^{-13} $\mu\text{Ci/ml}$. As a precaution, the HP placed MOVER workers on a monthly bioassay program versus the standard semi-annual sampling program. Radioactive contamination control swipes indicated that very little contamination was spread during the entire period of MOVER operation.

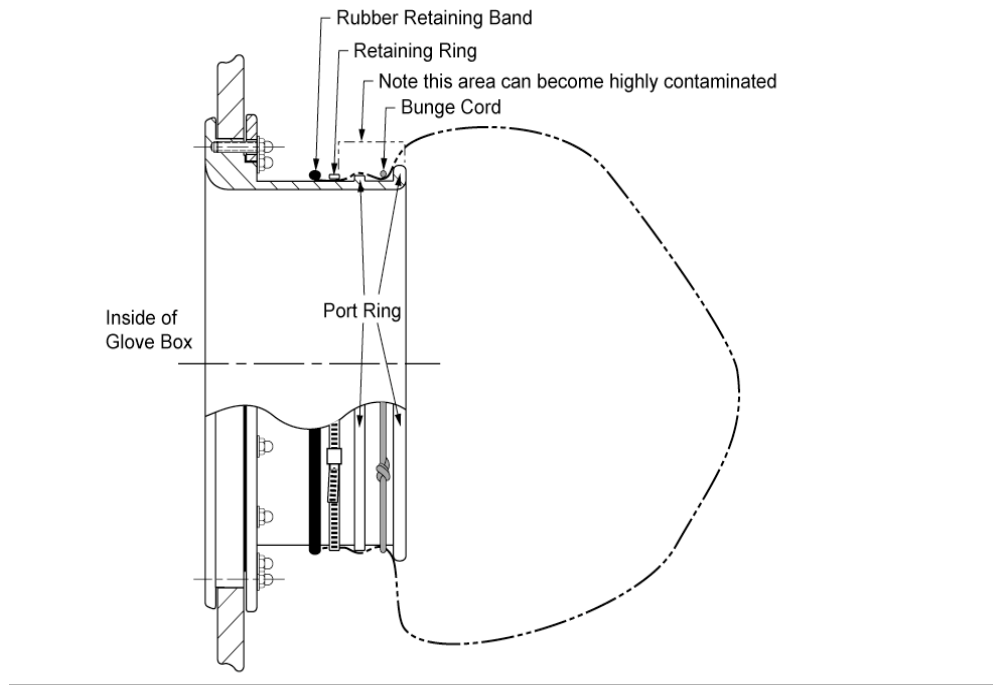
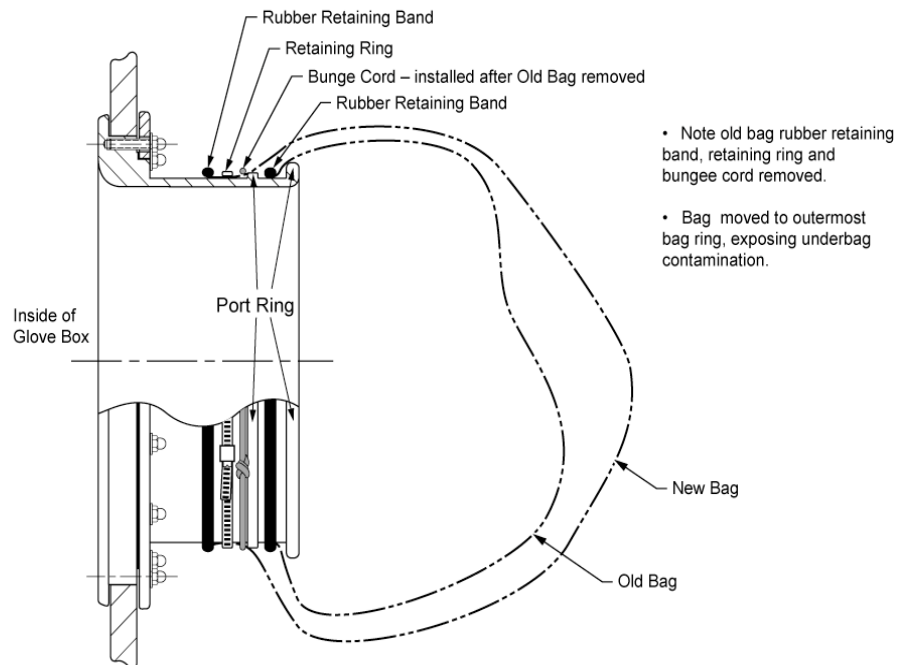
Figure 6. MOVER working configuration (top) and bag-change configuration (bottom).

When bags at the MOVER are left on the innermost port ring (closest to the glovebox), contamination can migrate along the port ring. When a bag needs to be changed, personnel remove the retaining (hose) clamp and rely completely on the rubber retaining band and move it to the outermost port ring. This operation physically scrapes areas that were previously exposed to the glovebox environment and leaves them exposed. Contamination in excess of tens of thousands of counts was observed on the bag port. The area was then decontaminated before the bag-change process continued. The Incident Analysis Team believes that operating processes resulting in conditions that required routine decontamination are less than adequate. Moving the drum bag to the first port ring could eliminate this contamination area along with the need to continuously clean the area of contamination. The combination of bag design and bag-installation techniques resulted in leak paths for contamination to exit the MOVER glovebox and become airborne.

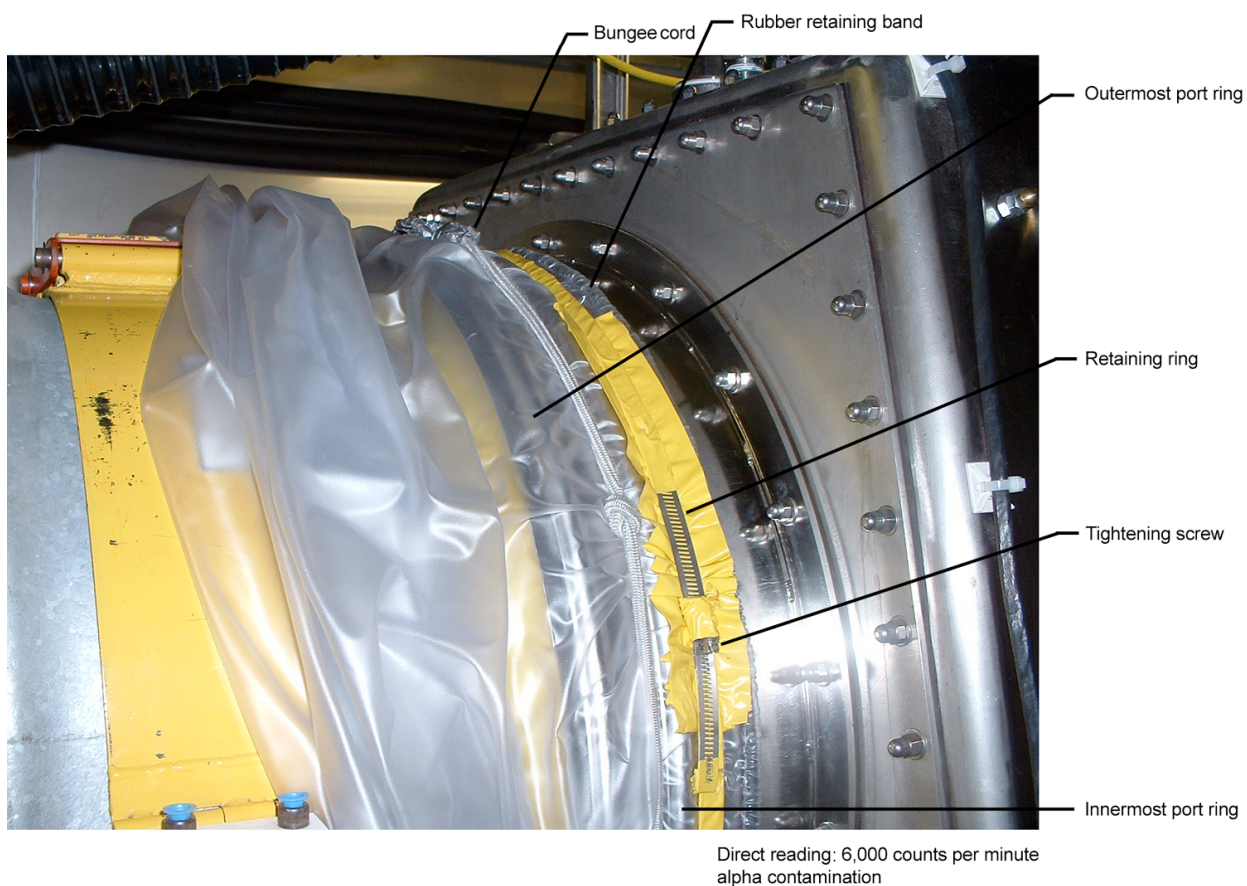
During the August 19, 2004, event, MOVER operators observed that the retaining band was not tightened adequately. CCP personnel attributed the problem to a worn clamp-tightening screw, and the clamp was subsequently replaced. The IA Committee believes that the clamp mechanism was never completely effective even in its normal state, and its degraded condition would have allowed more contamination to make its way through the retaining clamp to the area up to the rubber retaining ring. A third mechanism for providing a contamination seal (installed in June as suggested by LLNL ES&H personnel) was a bungee cord installed around the bag on the outboard side of the hose clamp to attempt to seal the drum bag to the bag port. The bungee cord had several knots, and the end hooks were still attached. The presence of knots and hooks, and the absence of pressure adjacent to them, provided for channels that contamination could pass through. Although the bungee cord may have had some effect on reducing contamination on the glovebox bag port, it was not totally effective as a seal.

Figure 8. Photo of MOVER configuration, August 19, 2004, showing bungee cord, rubber retaining band, retaining ring, and tightening screw.

Thus, the three sealing methods discussed above each provided a tortuous pathway for material to enter the air in the MOVER. As a result, a small amount of material could easily escape through the three compression seals because each had a leak path to the next seal, and eventually through the bag port interface.

Whereas the CCP design used two contamination rings to provide a seal, neither was effective. HP 1 and the HP SME identified the potential for leakage at the bag/bag-port interface. Their recommendation for an additional bag seal (bungee cord) was also ineffective in correcting this leak path. A positive seal of bag to the bag port is needed. A demonstrated and effective way to accomplish such a critical seal is to use 2-in.-wide vinyl tape overlapping the bag to the port.
